Interim Geotechnical Report – Turbines

INTERIM INTERPRETIVE GEOTECHNICAL REPORT

Palings Yard Wind Farm – Turbine Locations

SLR Ref: 650.30012.00000-R01
Version No: -v0.2
August 2022

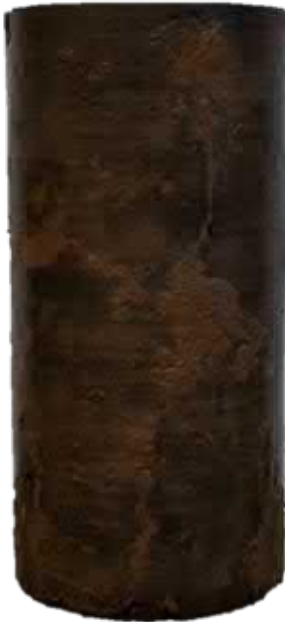
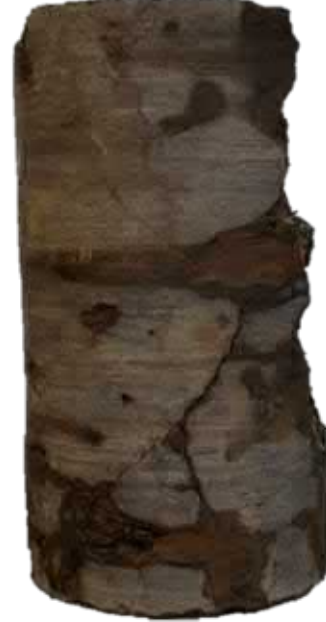
Depth	6.62-6.77		
Lithological Description	Igneous		
Type of Testing Machine	ILLACON02		
Date of Test	17/05/2022		
Height (mm)	120.3		
Diameter (mm)	60.9		
Test Duration (mins)	4.10	Rate Displacement (mm/min)	0.10
UCS (Mpa)	25	Moisture Content (%)	2.7

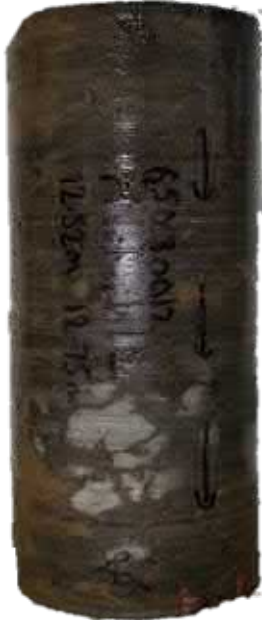
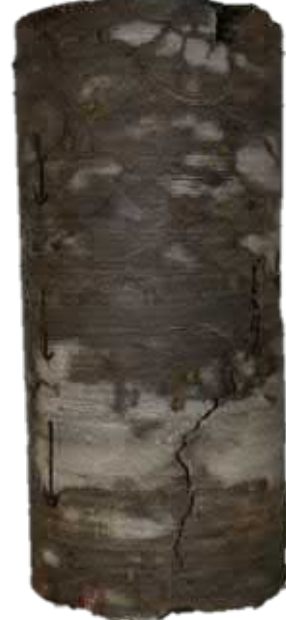
Depth	12.52-12.77		
Lithological Description	Igneous		
Type of Testing Machine	ILLACON02		
Date of Test	18/05/2022		
Height (mm)	154.7		
Diameter (mm)	60.9		
Test Duration (mins)	8.50	Rate Displacement (mm/min)	0.10
UCS (Mpa)	25	Moisture Content (%)	1.9

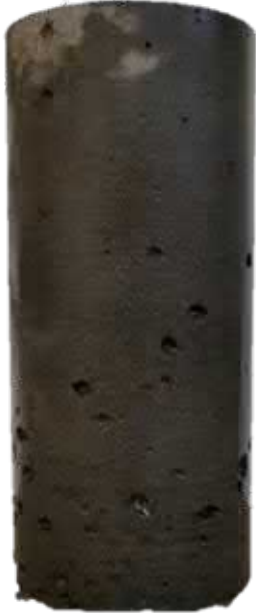
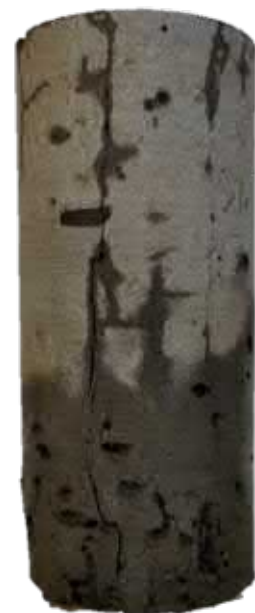
Depth	16.20-16.58		
Lithological Description	Igneous		
Type of Testing Machine	ILLACON02		
Date of Test	24/05/2022		
Height (mm)	153		
Diameter (mm)	60.9		
Test Duration (mins)	4.50	Rate Displacement (mm/min)	0.08
UCS (Mpa)	118.0	Moisture Content (%)	2.2

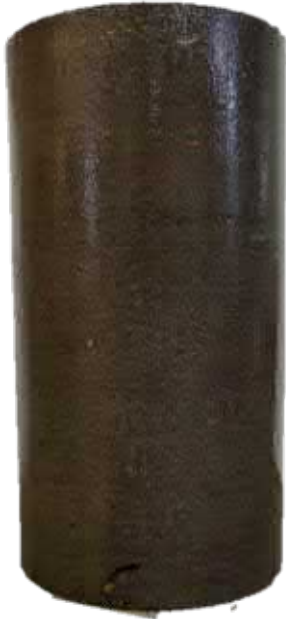
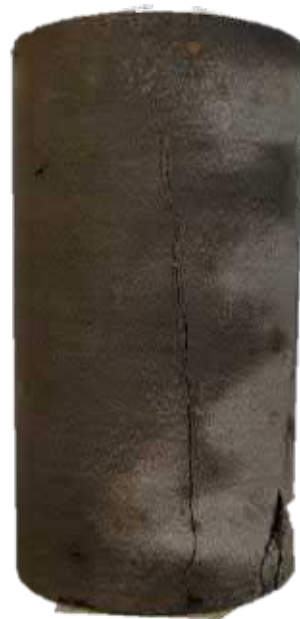
Depth	17.36-17.51		
Lithological Description	Igneous		
Type of Testing Machine	ILLACON02		
Date of Test	23/05/2022		
Height (mm)	129		
Diameter (mm)	61.1		
Test Duration (mins)	5.10	Rate Displacement (mm/min)	0.15
UCS (Mpa)	106.0	Moisture Content (%)	2.7

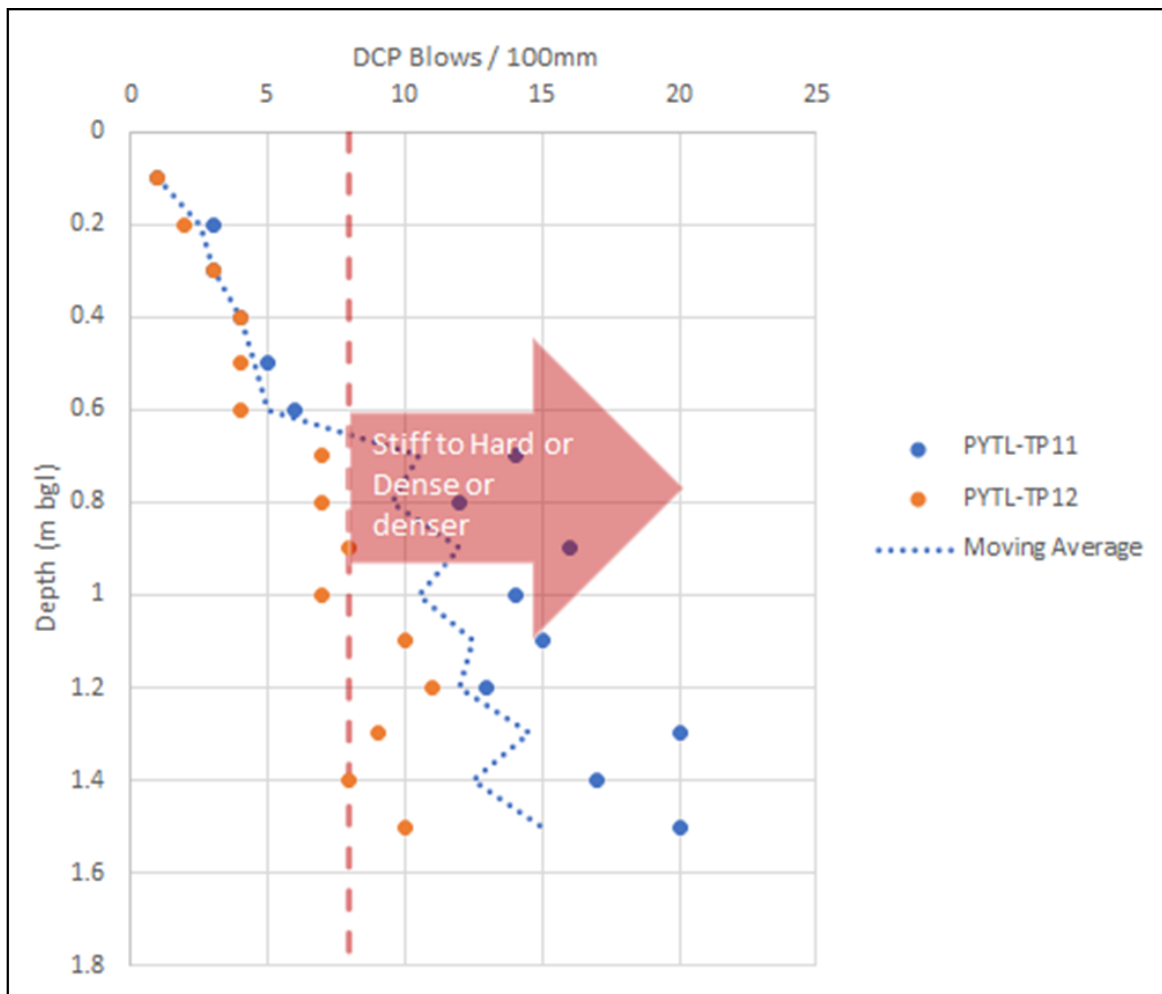
DCP tests also indicated that the soil consistency increased with depth in both excavated test pits as per **Figure 2**.

Figure 2 DCP test results
